SR 307 MP 1.34 Unnamed Tributary to Dogfish Creek (991999): Draft Preliminary Hydraulic Design Report

**Julie Heilman, PE, State Hydraulics Engineer, FPT20-00157
Y-12554 Olympic Region GEC**

Alex Morton, PE, Water Resources Engineer FPT20-10046, GeoEngineers

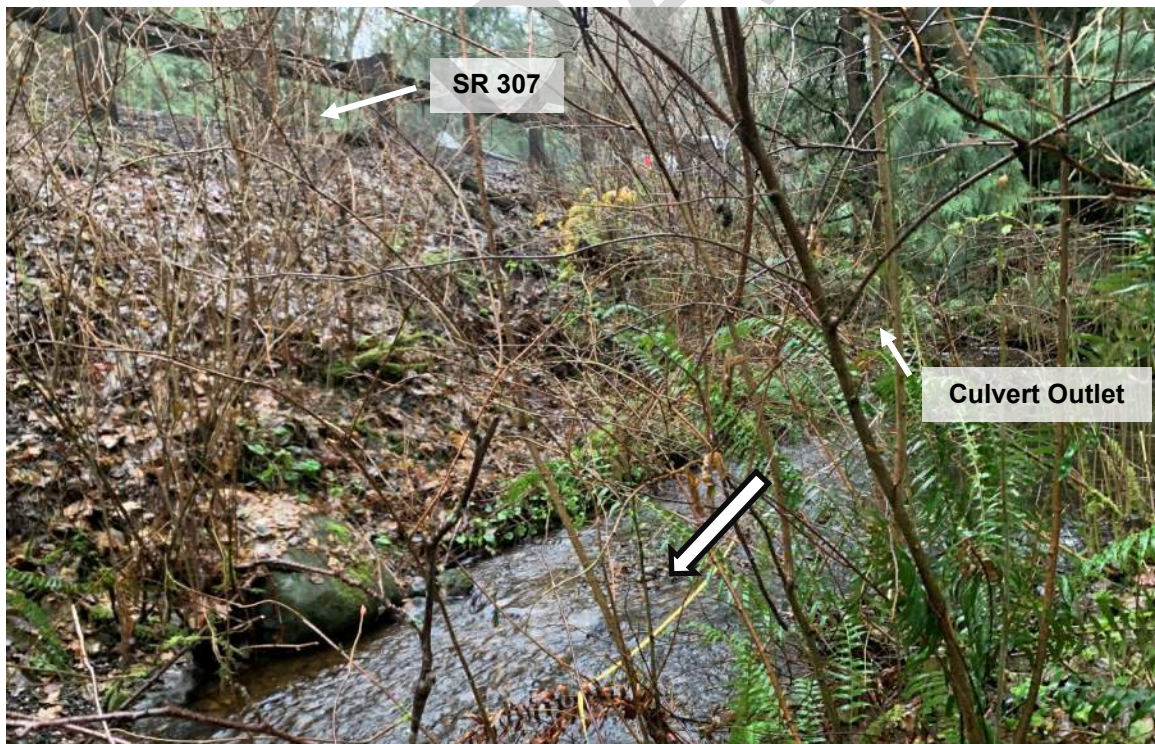
Figure 27: Riparian vegetation limited on rank bank (downstream orientation) due to SR 307 road embankment

Downstream of the 991999 crossing, NE Dogfish Creek flows adjacent to the SR 307 road prism through a forested area. Right bank vegetation is limited due to the SR307 road embankment (Figure 27). The left channel banks are vegetated with salmonberry, youth-on-age (*Tolmiea menziesii*), and sword fern. The overstory predominately consists of red alder (*Albus rubra*), western red cedar, and western hemlock (*Tsuga Heterophylla*).

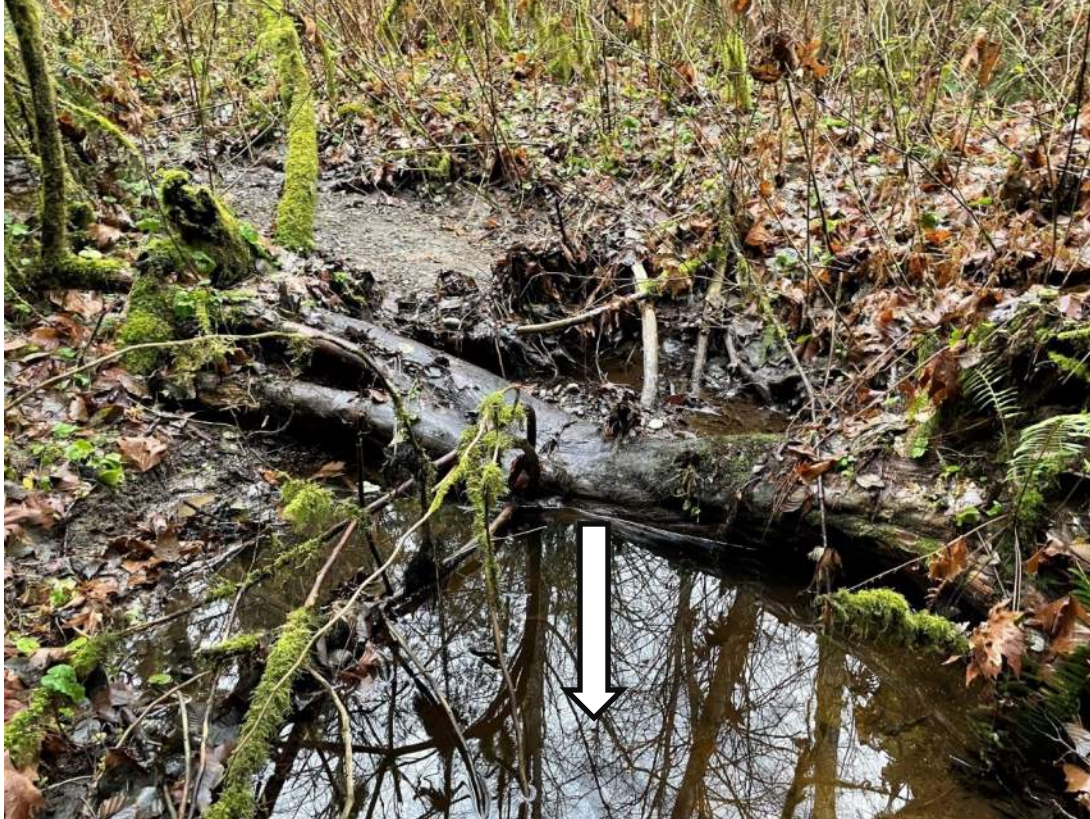
Figure 29: Channel spanning LWM in the high flow channel approximately 129 feet upstream of existing culvert

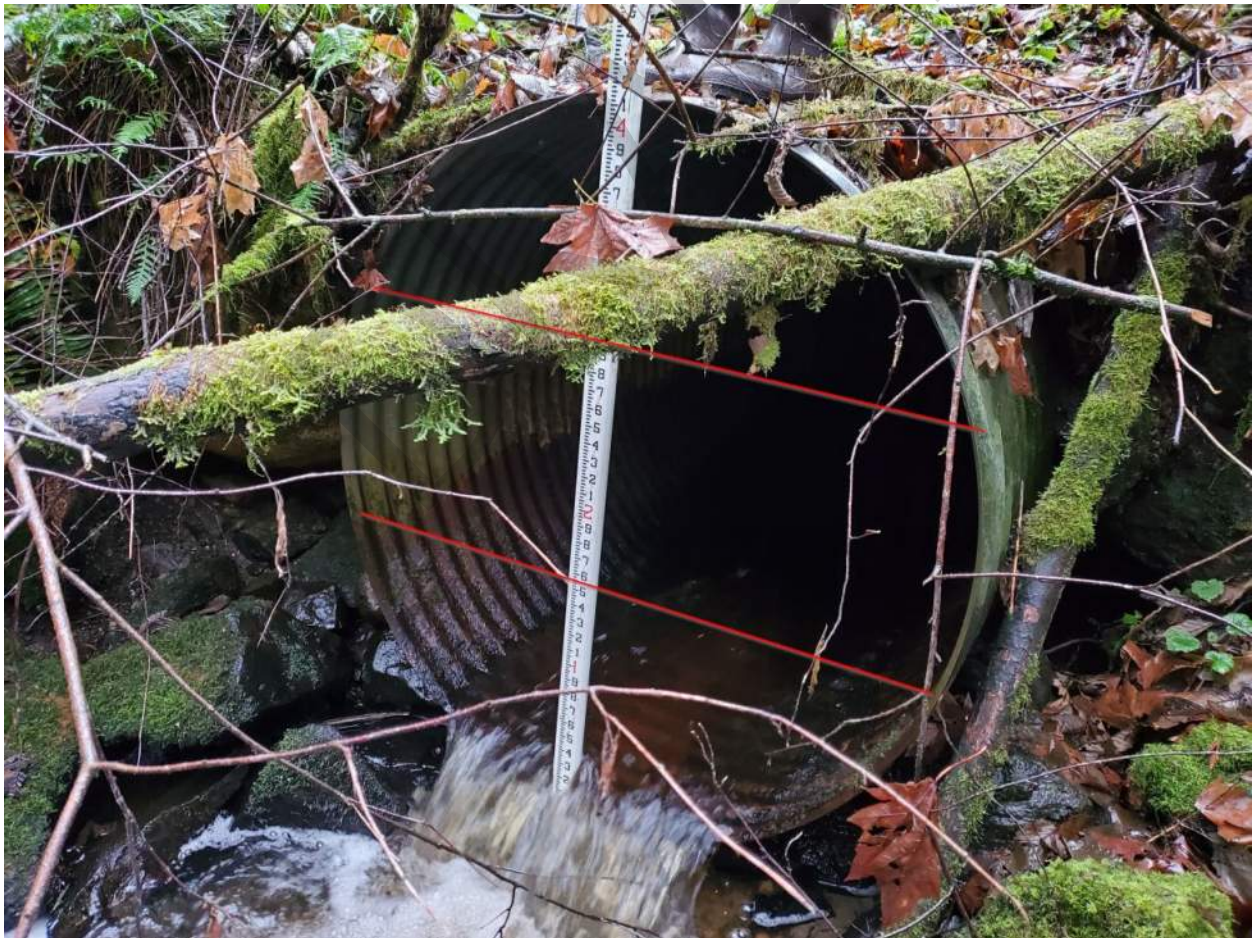
Figure 44. Crossing 991999 outlet with annotated rust and discoloration markings on stadia rod

While MGSFlood modeled flows depicted in Table 6 are consistently larger than the comparative methods, they appear in line with field observations. Upstream of the existing 991999 crossing backwater effect, existing conditions modeling using these flows report a 2-year maximum depth of approximately 2 feet (Table 14), depicted in Figure 63. This depth roughly correlates with observations of bank height and signs of scour typically associated with regularly occurring higher flow events. Further, there was a distinct rust line observed at the pipe outlet at just under 2 feet above the invert, with a second distinct coloration difference located approximately 3 feet above the invert (Figure 44). While these observations are highly approximate, they lend credence as a reality-check to these hydrology values as appropriate estimates for the system.

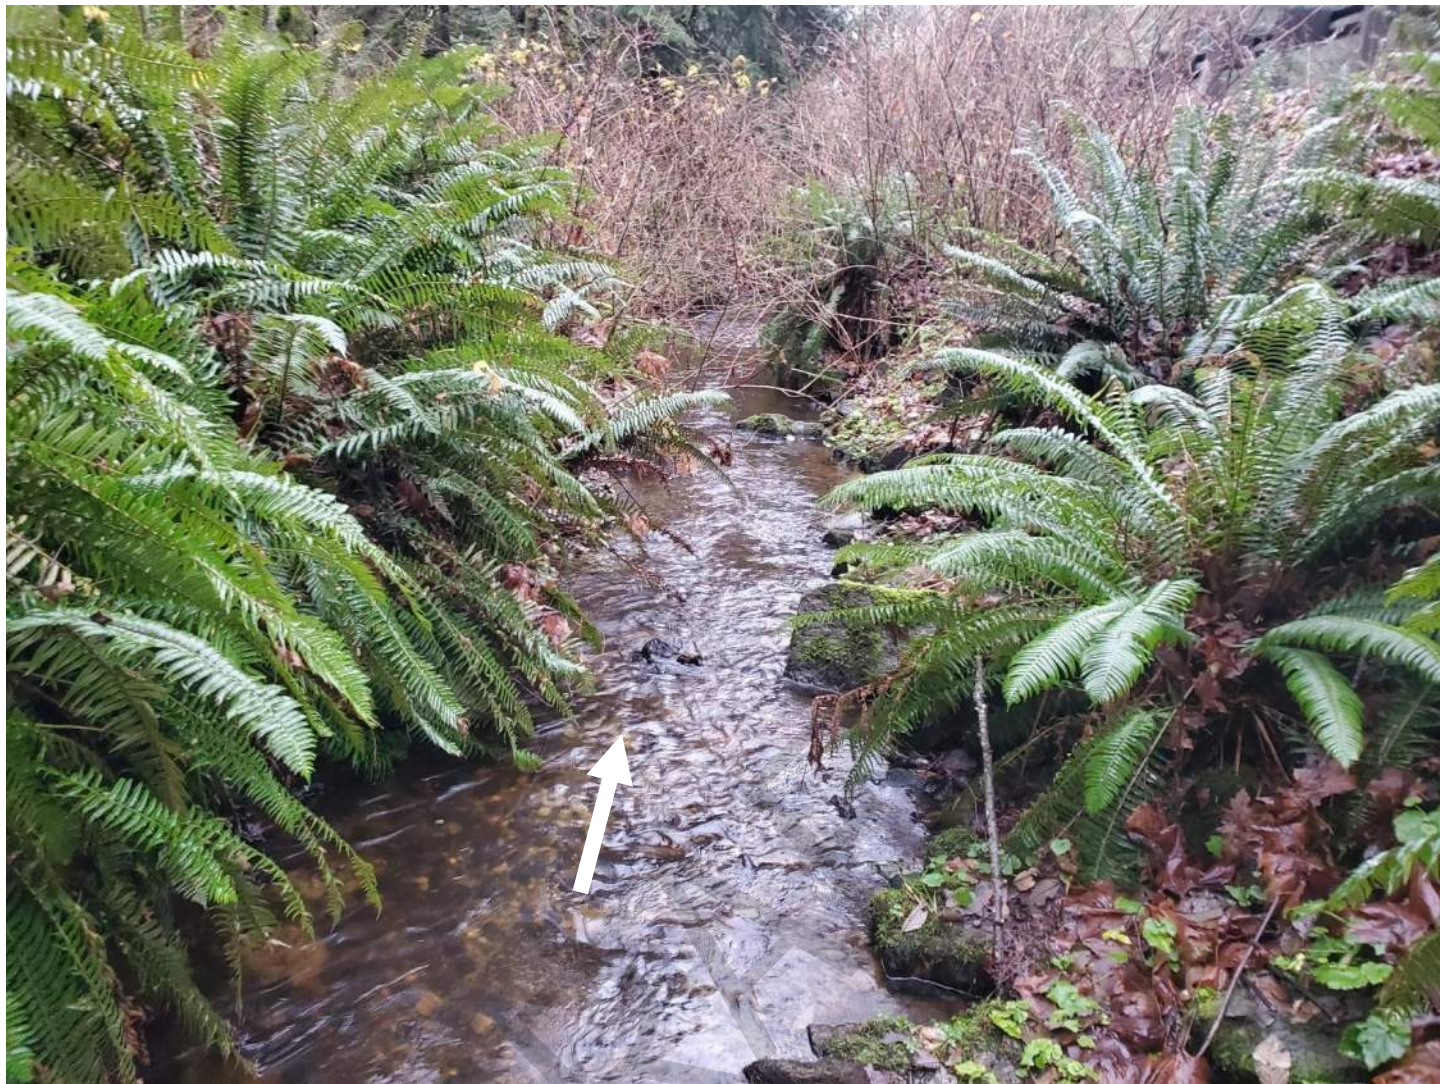
Figure 18: Highly confined conditions continue downstream of culvert, valley wall to the left, road embankment on the right, with occasional large boulders interacting with the channel along the right bank.

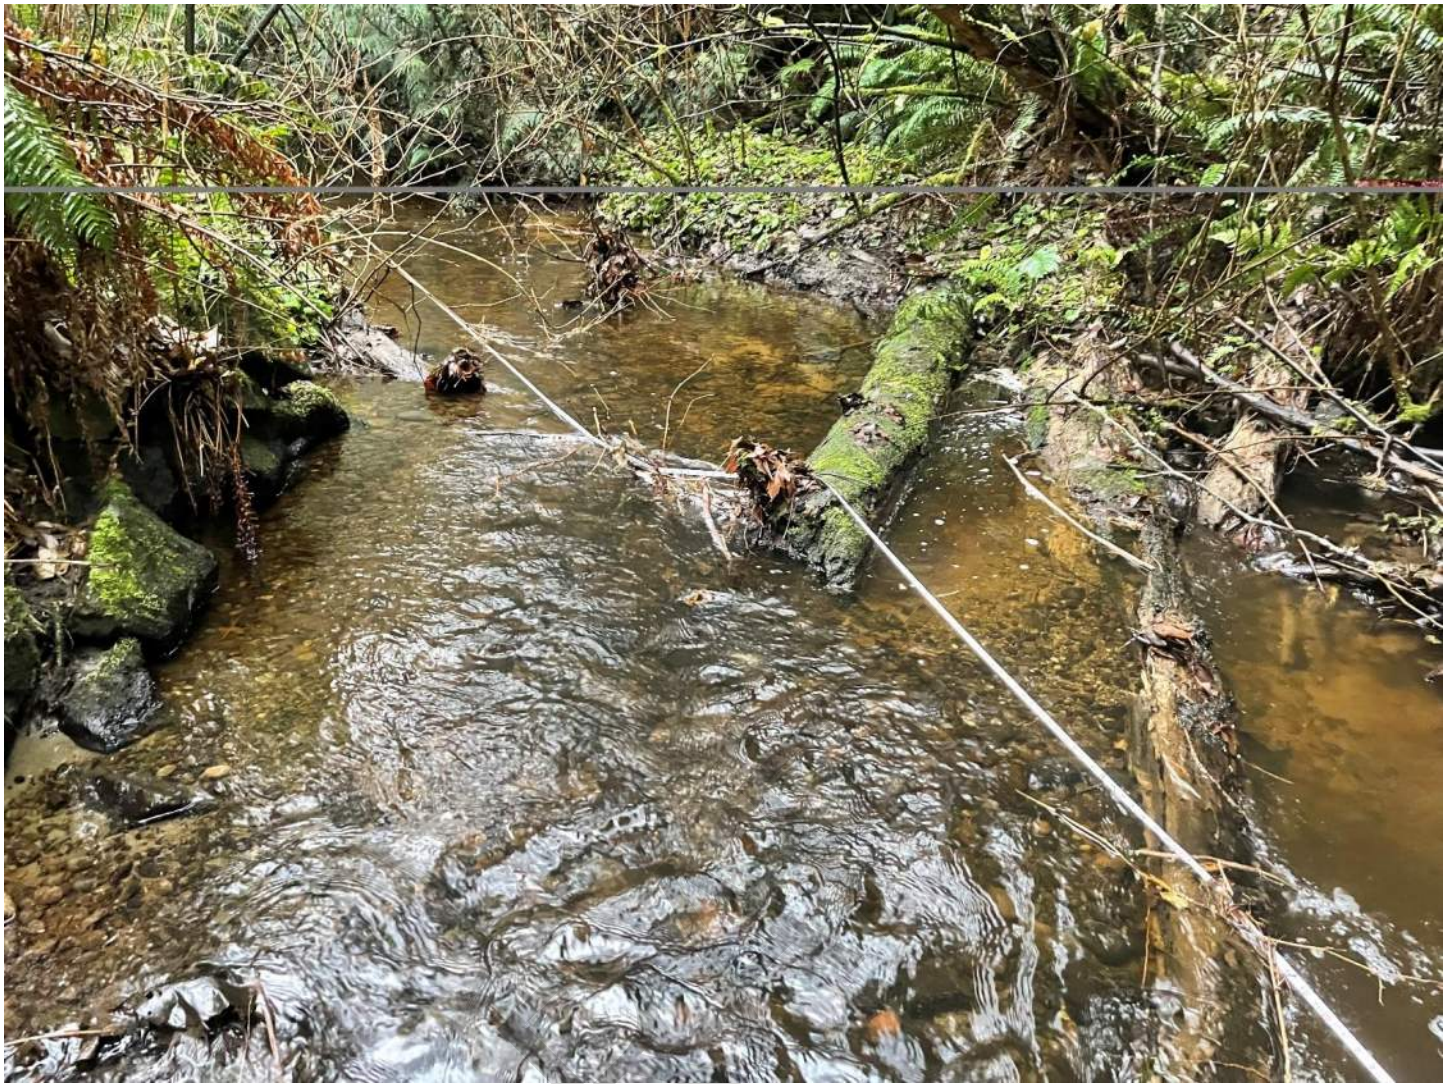
Figure 19: Occasional woody material forcing small pools.
